Post-Occupancy Evaluation (POE) in a group of Fundação Oswaldo Cruz (Fiocruz) buildings

The case of Instituto Fernandes Figueira (IFF)¹

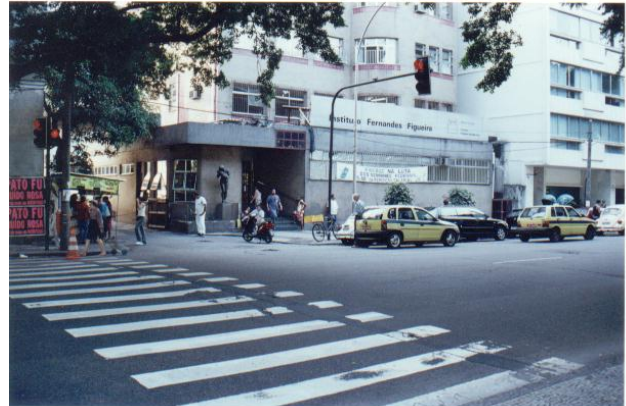
Figure 2. IFF's front, pedestrians and vehicles accesses

- There is only one access for vehicles, with no separation for cars, ambulances or trucks [2]. There are also inadequate flows of litters, incubators and bodies through internal streets. There are no organization or traffic signals to orient drivers and pedestrians, creating dangerous situations. It's necessary to create a hierarchy in the streets to avoid undesirable flows and dangerous situations.
- There are two different external pedestrian entrances, one for patients and other for servants [2]. At patients' entrance, the passage is not large enough for the entrance

and exit existing flows. The entrances have stairs, but not ramps. The floor coating is inadequate because it is polished. The roofs do not totally protect the stairs from the rain, so that the floor becomes slipping when it is wet. There are not ramps in the majority of internal accesses to buildings, which do not allow the entrance of physical deficient. The passage of wheel chairs is difficult because of the stone pavement and the gardens at sidewalks. Entrances and internal streets must be signalize and adapted to physical deficient free access.

- The cars usually park at the internal streets, making the maneuvers of service trucks difficult and blocking the sideways up, creating dangerous situations. The external parking is not large enough for the servants' vehicles. The parking at internal streets must be prohibited and another parking alternative must be created, outside the campus.

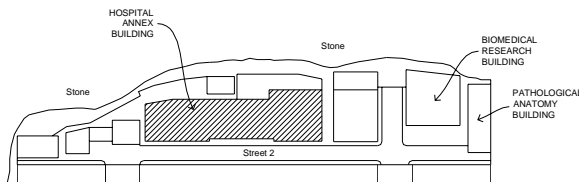
Figure 6. Hospital Annex Building

The most critical problems of hospital annex building are:

- The assistance rooms do not have enough space and are not soundproof. We advice the redistribution of activities in the building and the installation of acoustic coatings in these rooms.
- The access ramp is very sloping and inadequate for physical deficient. We advice installing an elevator for patients and servants.
- The electric, telephone and computer cables are not well fixed in many rooms. We advice fixing these cables in appropriate pipes.
- There are not sockets enough; damaged sockets; damaged windows and inadequate extinguishers. We advice installing more sockets, changing damaged sockets and windows and the inadequate extinguishers, according to the Fire Guard Norms. We also strongly recommend installing emergency sinalization.

In the users' opinion, the most critical problems in this building are: fire security, physical deficient accessibilty, internal sinalization, rooms' size and security against strangers in the rooms.

There must be great spatial interventions to adequate this building to the existing activities. So, we advice a relocation planning for the assistance departments, taking in consideration the hospital building's spaces.
