**XIII ISUF Conference**  
Ouro Preto/MG, Brasil

**BELVEDERE III – AN ANALYSIS OF AN URBAN OCCUPATION IN AN ENVIRONMENTAL PRESERVATION AREA AND ITS CONSEQUENCES ON THE LANDSCAPE**

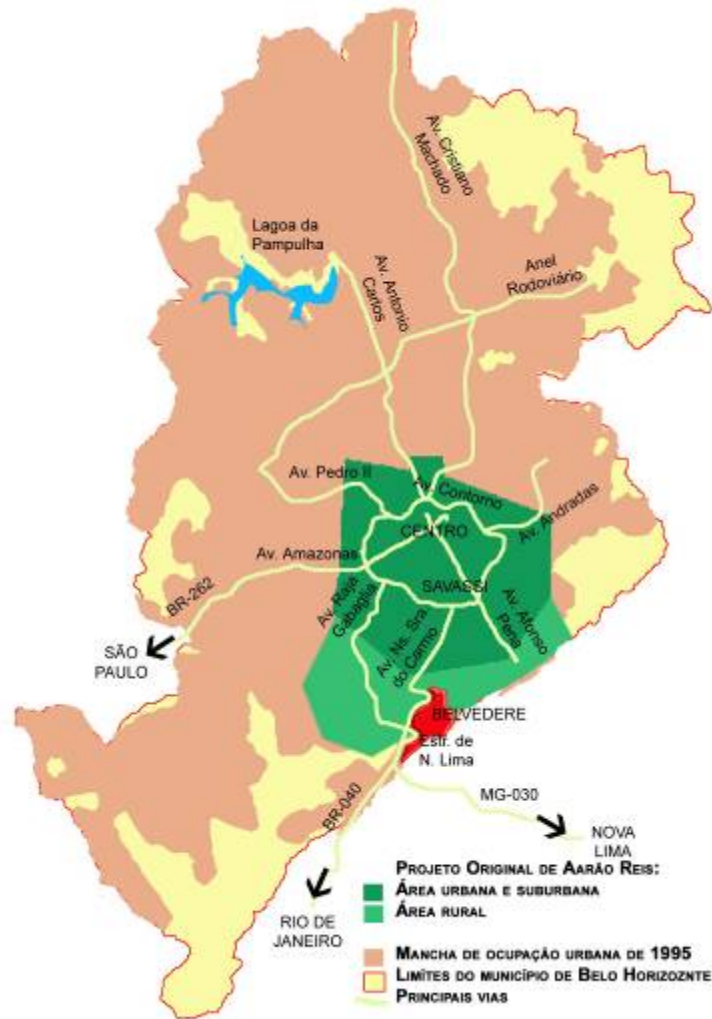
FIGURE 1: Original Plan for the City of Belo Horizonte by Araão Reis.  
Source: PBH, 1995. Map made by Flavia Amorim, 2007.

The new building models followed a concept which aimed to create a "healthier and more organized" city with large avenues and many green spaces. The road system followed an orthogonal design setting inside the urban expansion limit, corresponding to *Sete de Setembro* Avenue, presently *Contorno* Avenue, consisting on a ring that originally skirted the city building area. Today this region belongs to the South-Center Regional Administrative Sector, composed by the downtown district and some of the southern zone neighborhoods.

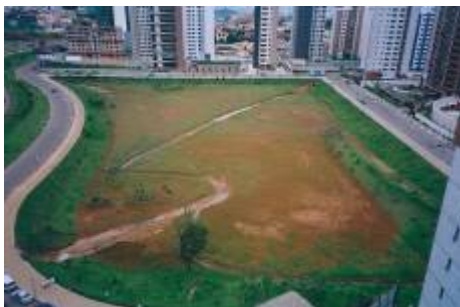
FIGURE 3: *Lagoa Seca* square  
Photo by Flavia Amorim, 2000

There is an existing square in Belvedere III, called *Lagoa Seca*, named after the water level intermittence characteristics (PBH, 1994, apud: Cortizo, 2002). The *Lagoa Seca* is currently the main area for rain water recharge of the district. This aspect is determined by the relief profile and by the underground components.(Ferreira, 2003).

This area plays important role in the water supply and reservation, preventing the flooding occurrences in the neighborhood. All the rain water is drained to that lake and from there, it goes to *Córrego Cercadinho*.

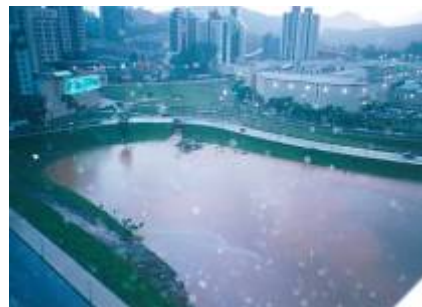
FIGURE 4: *Lagoa Seca* flooding  
Source: Belvedere's District Friends Association, 1999

The occupation of the lake area could aggravate the critical situation of underground water levels and recharge flows of *Córrego Cercadinho*. The Belvedere urbanization was responsible for a significant reduction of the lake covered area, what resulted in a considerable decrease of the absorption capacity.

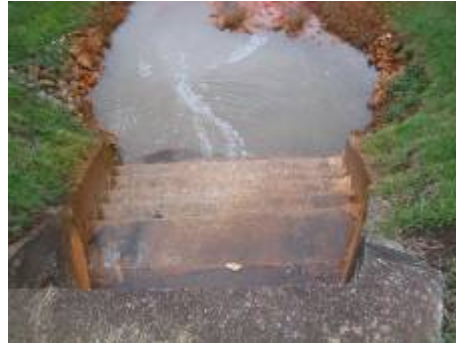
Other problem we can point out is the pollution which penetrates the ground and residuary water infiltration in the lake, as pointed by Ferreira (2003). The contamination of the rain water launched in the *Córrego Cercadinho* characterizes serious environmental infraction and has negative consequences on the water and soil quality.

FIGURE 5: Polluted water disposal in Lagoa Seca  
Picture made by Flavia Amorim, 2006

Maura Ferreira indicates that the main cause for the rain water pollution comes from the road system, as it receives oils, greases and other vehicle dirt, led to *Lagoa Seca* and *Córrego Cercadinho*. Another pollution source is the sanitary disposals, launched illegally in the lake (Ferreira, 2003).

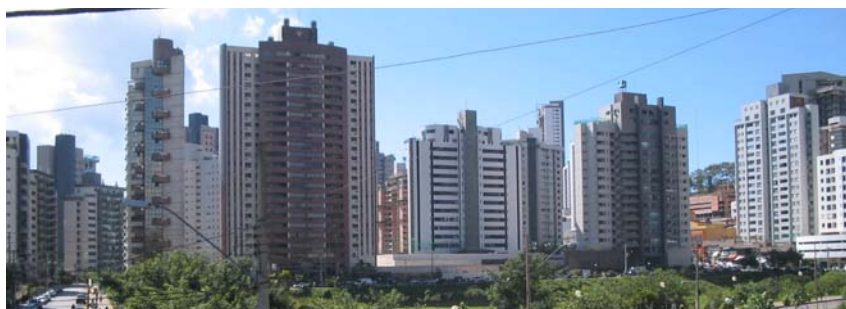
FIGURE 6: Building types characteristics  
Photo made by Flavia Amorim, 2005

One of the most visible impacts of the Belvedere occupation is the modification on the building types. The area was originally empty and the neighborhood blocks were composed essentially by one-family housing constructions. The Belvedere’s high towers present an aggressive modification on the original landscape.

Along with the building disparity, the other problem is the visual barrier to *Serra do Curral* sight. The mountain is the city’s main landscape reference, considered by the population as the capital identity, and a national heritage, but is hidden by the Belvedere skyline buildings.
